COMMONWEALTH OF KENTUCKY
BEFORE THE PUBLIC SERVICE COMMISSION

GREEN RIVER ELECTRIC CORPORATION)	
)	
<hr style="width:40%; margin-left:0"/>)	CASE NO. 96-169
)	
ALLEGED VIOLATIONS OF COMMISSION)	
REGULATION 807 KAR 5:041, SECTION 3(1))

UTILITY ACCIDENT INVESTIGATION REPORT

Utility:	Green River Electric Corporation				
Reported By:	Tammy Montgomery				
Dates & Times:					
Accident Occurred:	11/13/95 - 12:15 pm EST				
Utility Notified:	11/13/95 - 12:30 pm EST				
PSC Notified:	11/13/95 - 12:40 pm EST				
Investigated:	11/14/95				
Written Report Rcvd:	11/14/95				
Location of Accident:	5440 Medley Road in Daviess County, Kentucky				
Description of Accident:	The right-of-way crew was in the process of setting up the bucket truck to remove limbs approximately 3-4' from the energized conductor. Mr. Jerry Landgon was attempting to attach the truck ground to the system neutral. The truck ground cable became entangled with a siderail on the truck and in an attempt by Mr. Jerry Landgon to free the cable, the cable made contact with the 7200V phase. Mr. Mike Barnes was standing on the ground next to the wheel of the chipper. He received electrical shock and burns when the ground cable mad

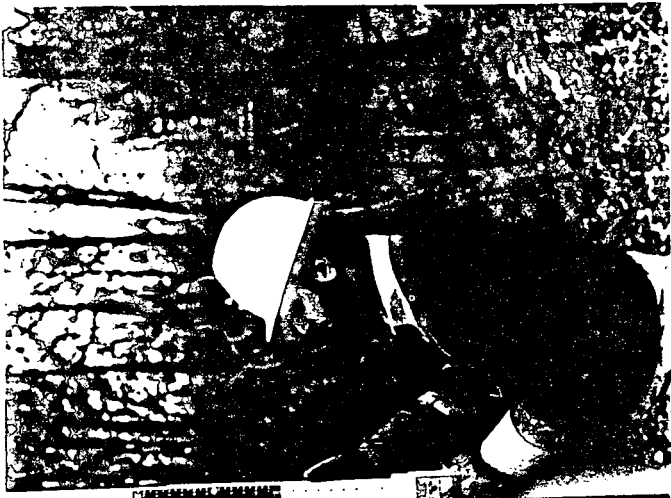
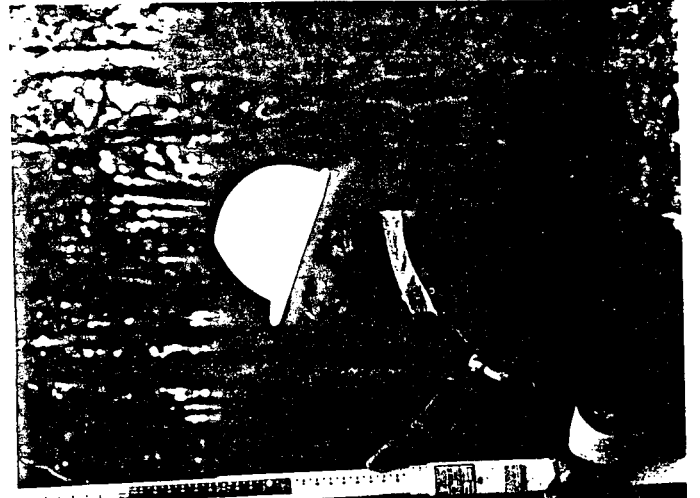
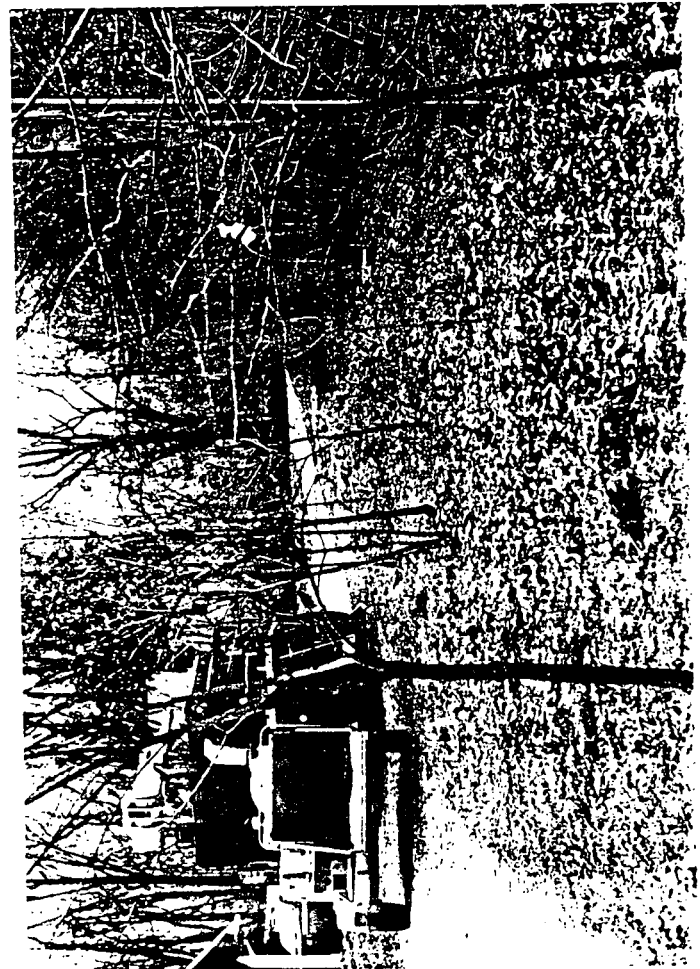
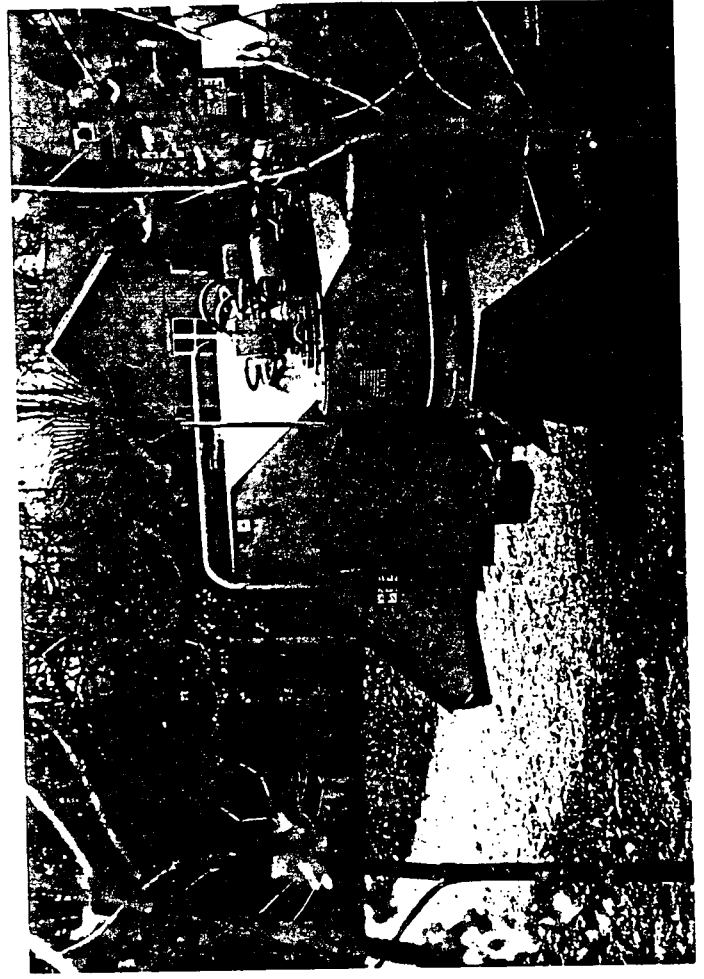
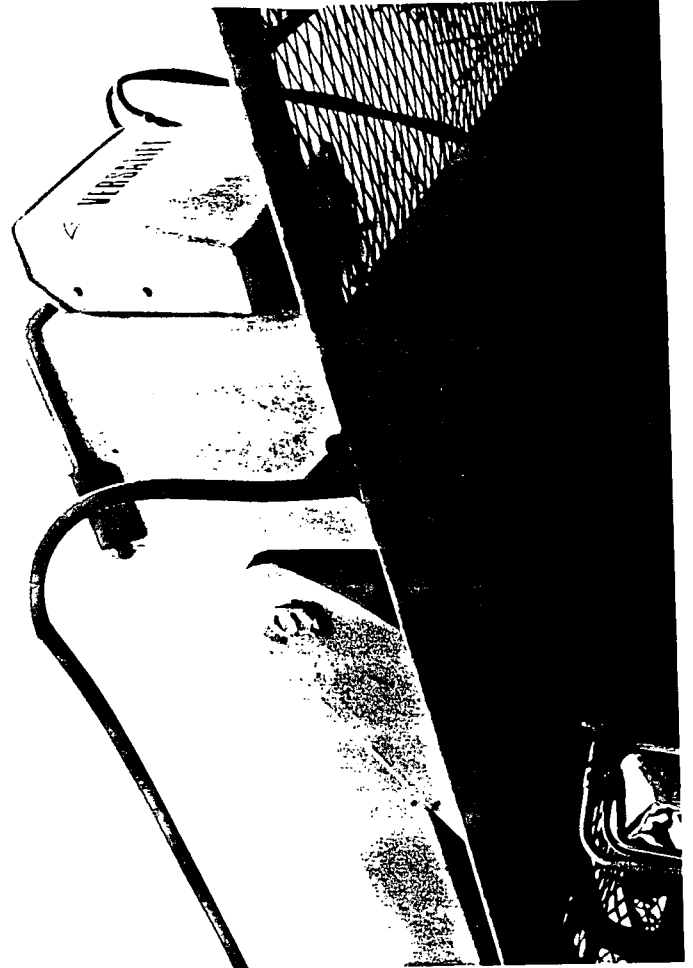
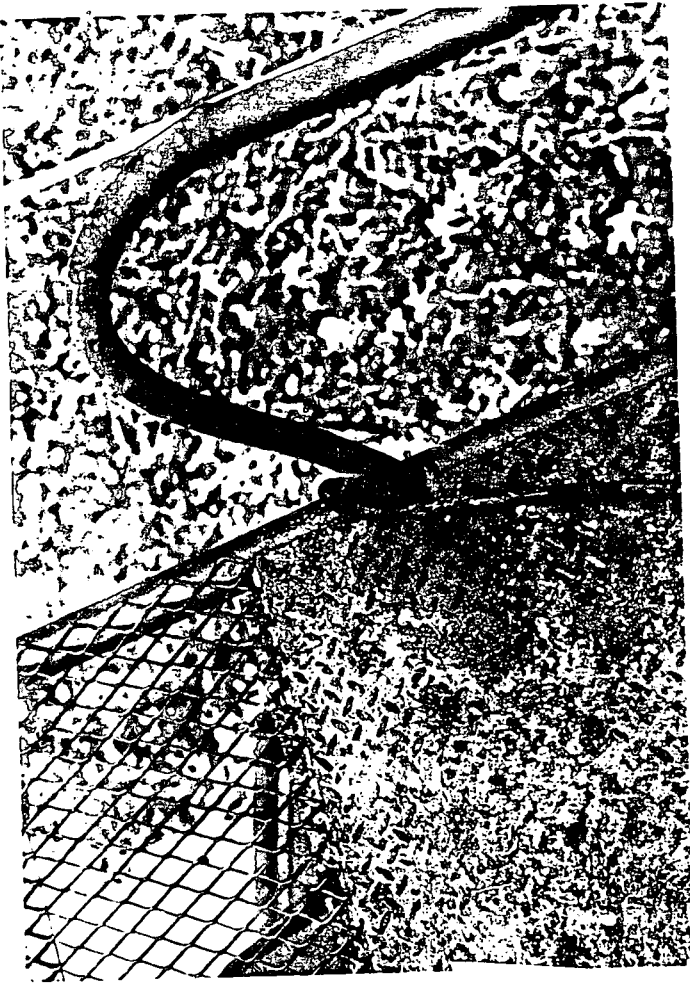
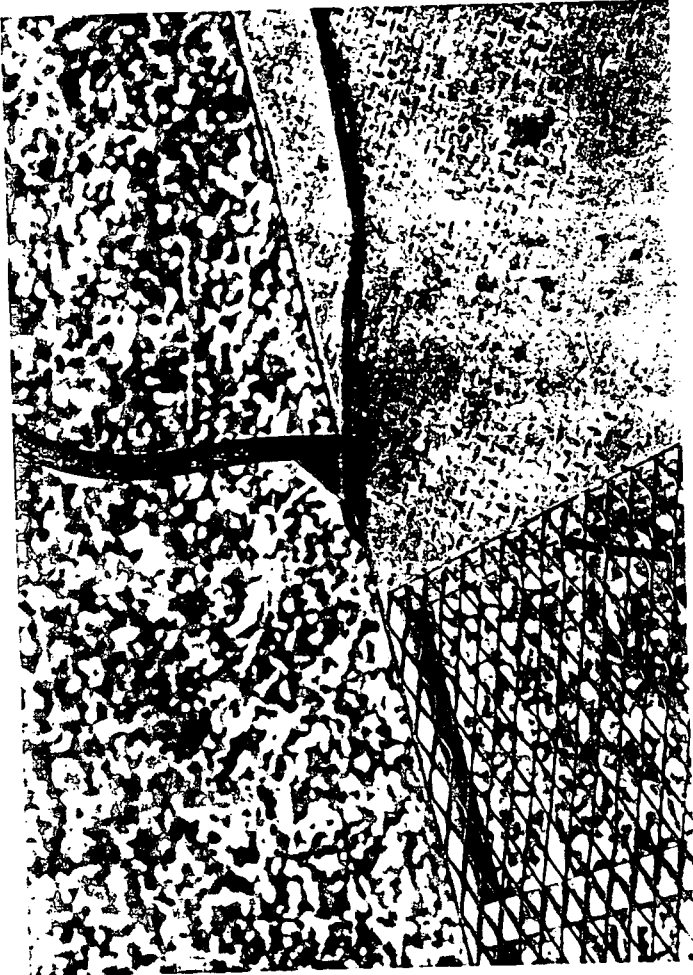
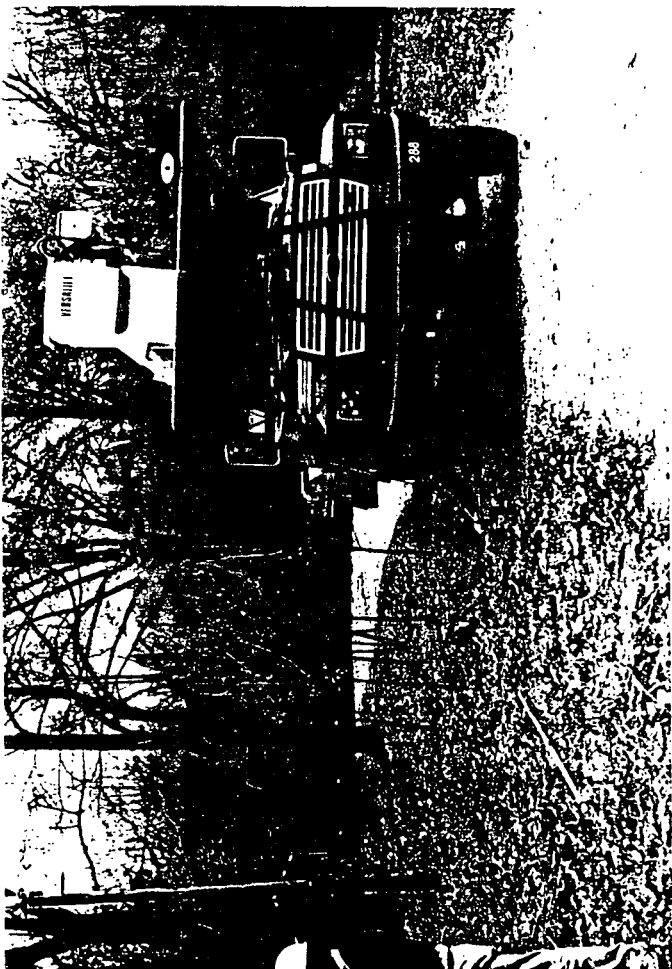
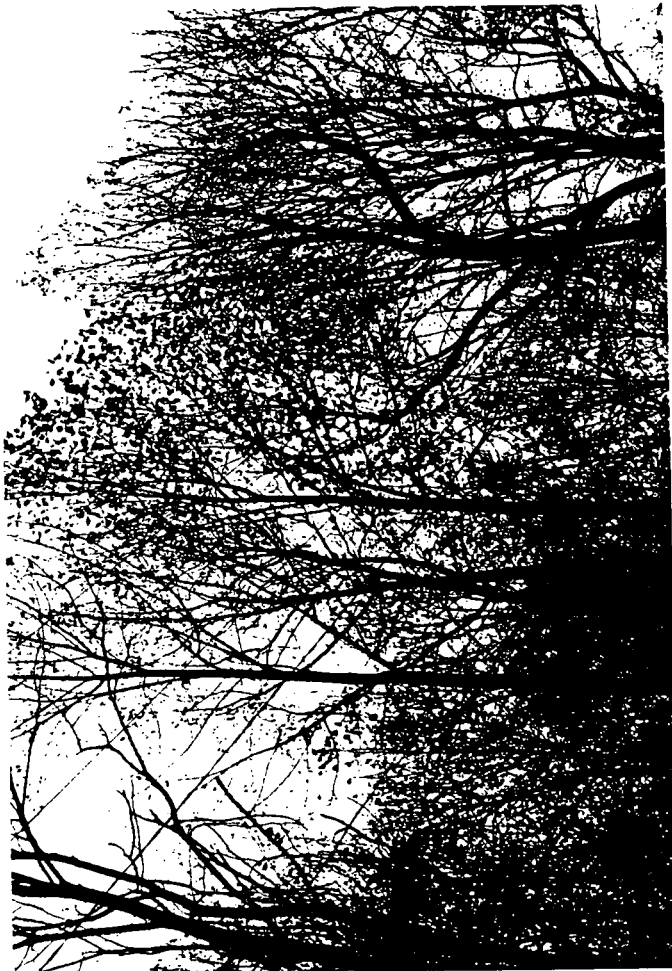
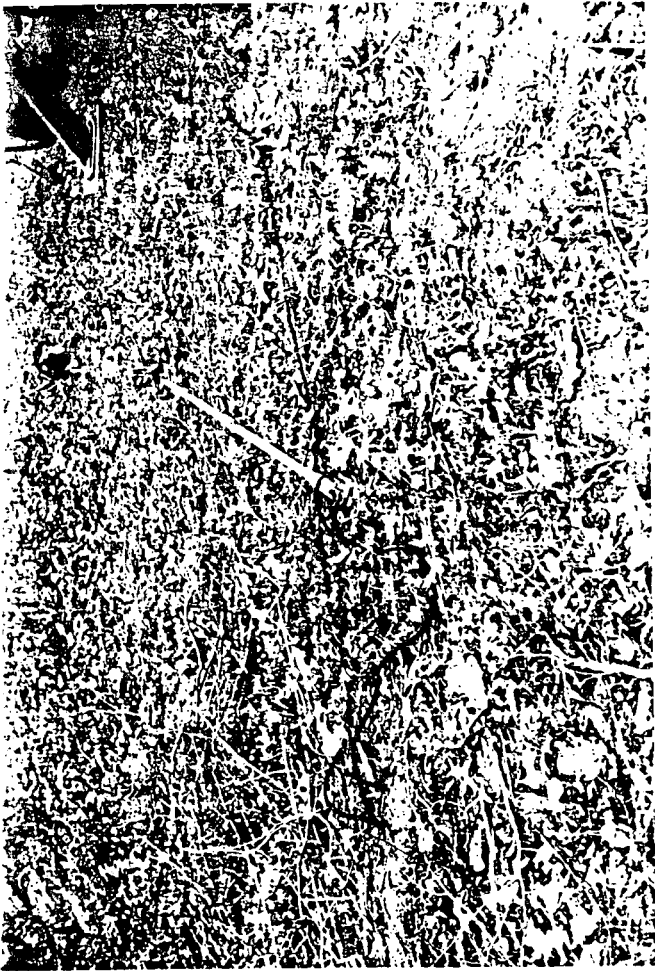
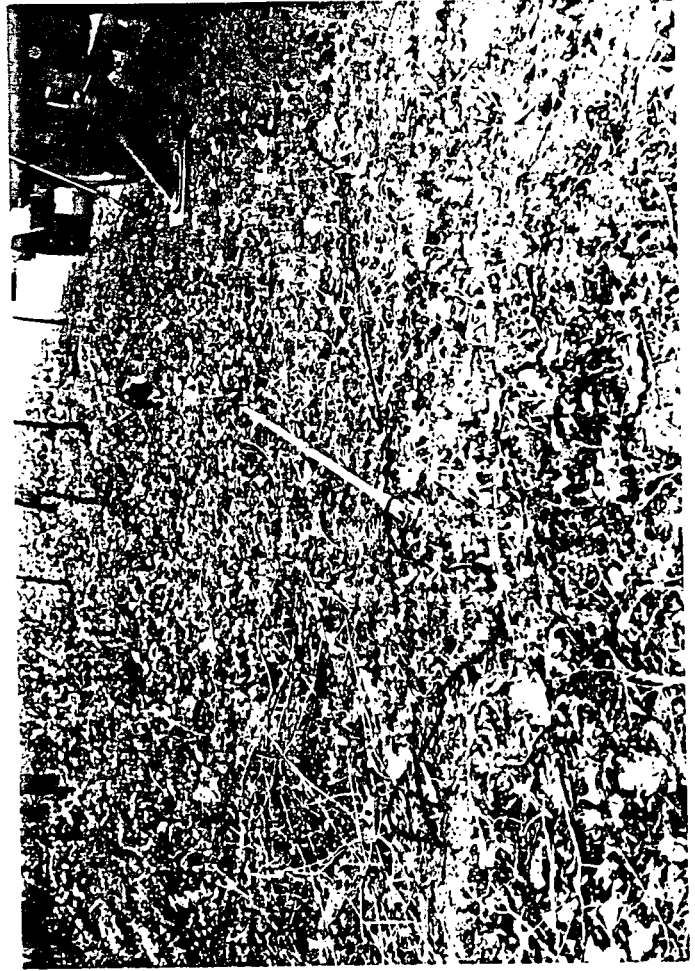
ATTACHMENT E

Jerry Langdon working as a Laborer had been assigned to the Right-of-Way Section in May 1995. Prior to being assigned to the Right-of-Way Section, Jerry worked in materials and was assigned standby duties with a qualified lineman. Jerry was alone in the bucket and was attempting to attach the truck ground to the system neutral at a point approximately 60' from the dead end pole. The truck ground cable became entangled with a side rail on the truck and in an attempt to free the cable he made contact with an energized conductor.

The Safety Committee reviewed the accident and has filed the attached report. The Committee's report and the Operations Supervisors' review of the accident basically agree on the cause of the accident. First, they determined that the bucket was positioned too high, and secondly, the worker was not being directly supervised. The bucket had been positioned with the top of the bucket level with the neutral conductor and within 12" of the conductor. Jerry was using an 8' hotstick to attach the cable. He was attempting to free the cable from the rail by jerking it in an upward motion when contact was made. It was determined that the bucket should have been positioned approximately 6' below the neutral and in an area where contact could not be made.

The absence of direct supervision by Mike has been determined as the primary cause of the accident. Had Mike been closely observing the work in progress, he would not

I am recommending that disciplinary action be taken. More specifically, I recommend Jerry receive a two day suspension without pay and Mike receive a three day suspension without pay. I do not recommend probation for either employee.
